Sudden Impedance Rise (SIR)

*The common cause of Stationary
Battery related UPS failures*

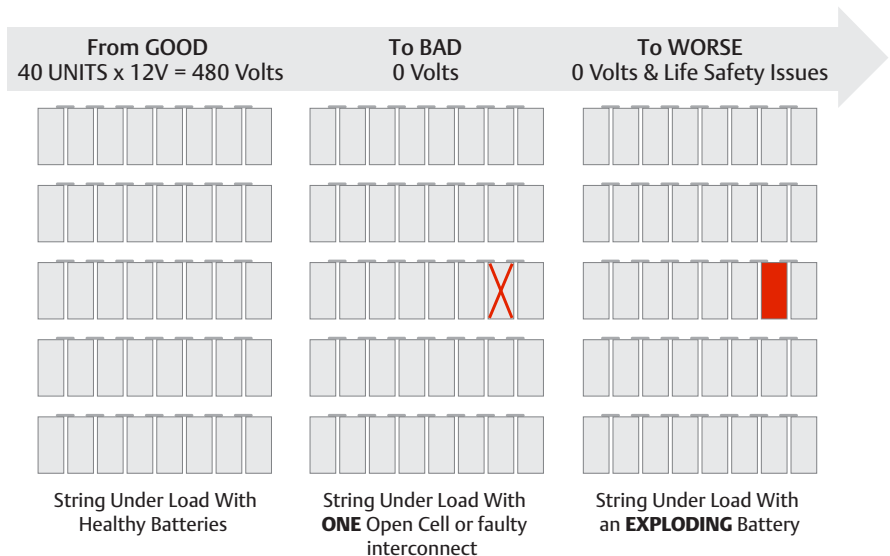
Sudden Impedance Rise (SIR) in a Stationary Battery is indicated by an exponential rise of internal resistance over a period of 2–4 weeks. SIR, which can occur at anytime in the serviceable life of a battery, is a common form of battery failure. A SIR battery (if not replaced) will open, jeopardizing the integrity and reliability of the UPS. In the worst case, a failed open cell can even explode under load conditions, jeopardizing safety.

Figure 1: Only one open cell can cause a string to fail

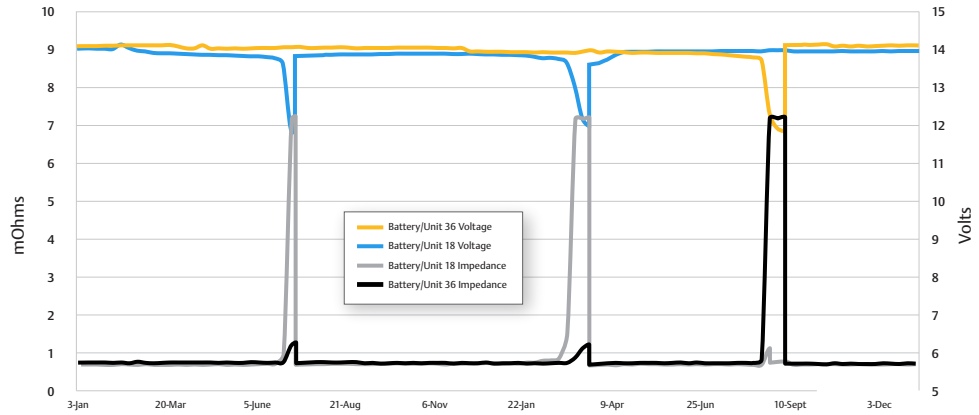
The first three cases below are all from the same string of batteries installed at a well-designed and well-operated Tier III datacenter of a major financial institution. This string and the redundant system at this site have been less eventful as the strings matured.

Chart 1: 3 cases of sudden impedance rise from a single datacenter

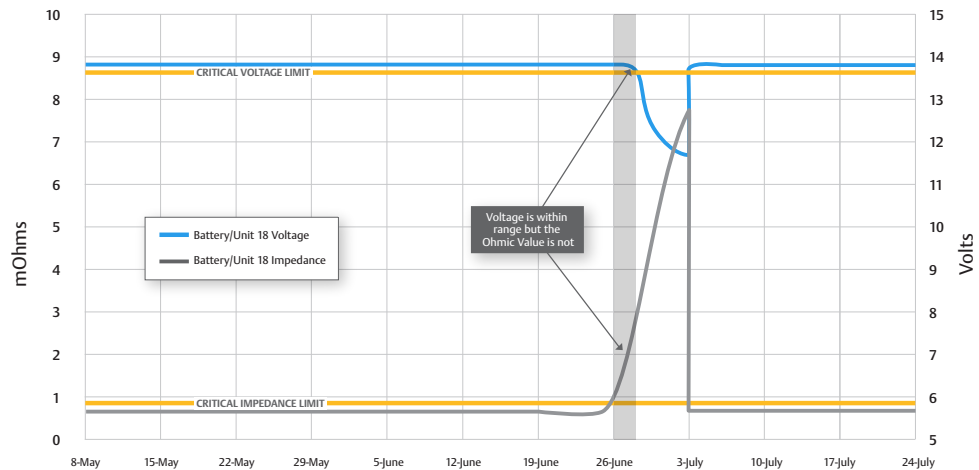
Chart 2 shows a flooded battery with an initial ohmic value of 0.67mΩ. The maintenance threshold on this battery would be 0.77mΩ and the replacement threshold would be 0.8mΩ. This battery was installed in December and trended normally until late May 22. A “Spot Test” associated with quarterly maintenance on June 19 would have shown this battery to be within acceptable standards, the voltage level may have called for a recommendation to equalize the string.

Chart 2: Battery/Unit 18: a flooded battery showing a sudden impedance/resistance rise

SIR is clearly indicated from June 26 to July 10 and the battery was replaced by July 17. The Voltage Trend demonstrates a corresponding fall in voltage sometimes associated with the rise in impedance/resistance.

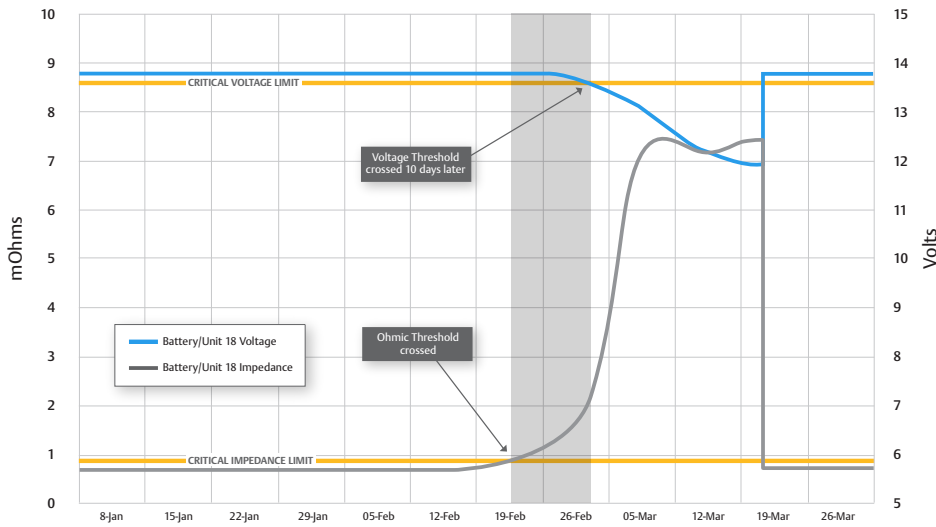
Chart 3 shows a flooded battery with an initial impedance/resistance of 0.69mΩ. The maintenance threshold on this battery would be 0.79mΩ and the replacement threshold would be 0.83mΩ. This battery was installed in July replacing the battery in Chart 2 and trended normally until late February.

Chart 3: Battery/Unit 18 was replaced in early July and failed in only 7 months, again showing SIR

This case could be considered infant mortality as the battery replaced in Case 1 above failed in only 7 months. By monitoring and storing the key vital signs, this battery was replaced under warranty, and a potential outage was avoided.

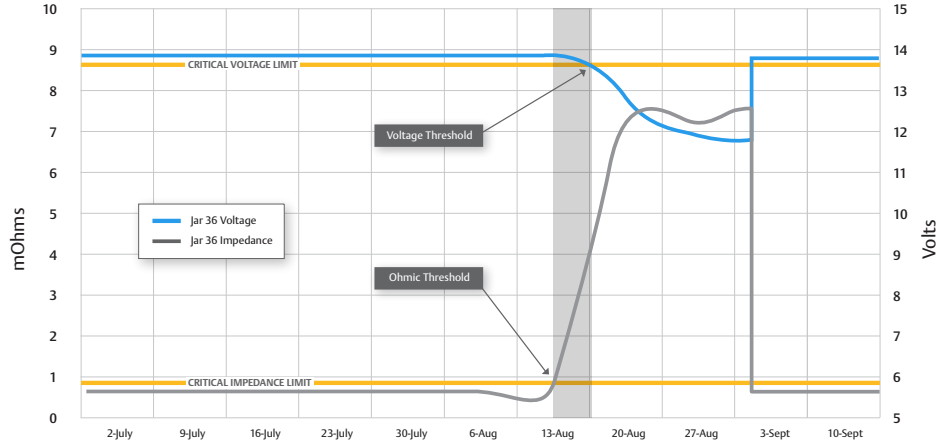
Chart 4 shows a flooded battery with an initial impedance/resistance of 0.69mΩ. The maintenance threshold on this battery would be 0.79mΩ and the replacement threshold would be 0.83mΩ. This battery was installed in December and trended normally until late August.

Chart 4: The impedance rise provides earlier insight into the battery

Like Case 2, this battery was replaced under warranty, and a potential outage was avoided.

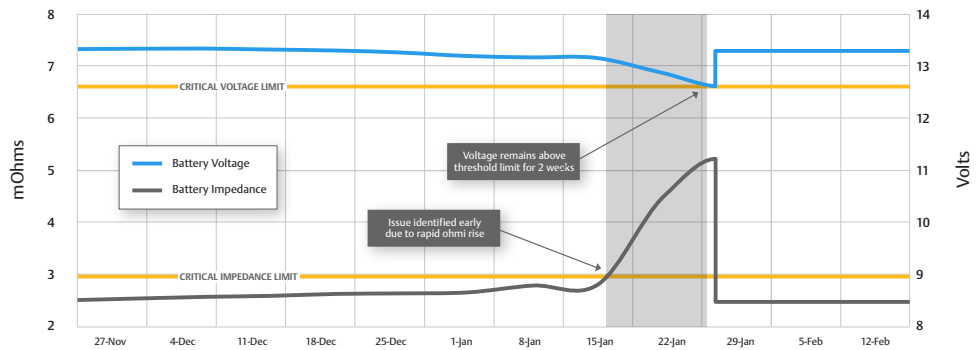
Chart 5 shows a VRLA battery with an initial ohmic value of 2.5mΩ. The maintenance threshold on this battery would be 3.0mΩ and the replacement threshold would be 3.125mΩ. This battery was installed in August and trended normally until late November.

Chart 5: SIR indicates imminent battery failure

The Voltage Trend demonstrates a corresponding fall in voltage sometimes associated with the rise in ohmic value. Also note that the replacement battery was not fully charged at the time of installation. This new battery was installed in an undercharged condition and took 8 weeks to equalize with the string.

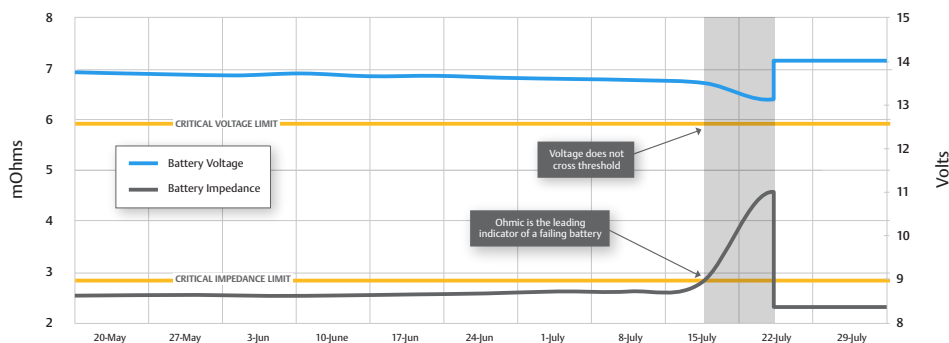
Chart 6 shows a VRLA battery with an initial impedance/resistance of 2.4mΩ. The maintenance threshold on this battery would be 2.88mΩ and the replacement threshold would be 3.0mΩ.

This battery was installed in February and trended normally until late July.

Chart 6: Voltage drops but remains within limits, where Ohmic surpasses threshold quickly

SIR in this case occurred in just 2 weeks and the battery was replaced immediately. The Voltage Trend again demonstrates a corresponding fall in voltage sometimes associated with the rise in impedance/resistance but remains within limits. Voltage is the lagging indicator in up to 30% of battery failures. In this case the new battery was overcharged at the time of installation and remained above 2.27 volts per cell for 6 weeks. Float voltages exceeding 2.27 volts per cell will reduce battery life.
